**COST Action TU0901:  
Integrating and Harmonizing Sound Insulation Aspects  
in Sustainable Urban Housing Constructions**

# **Building acoustics throughout Europe Volume 2: Housing and construction types country by country**

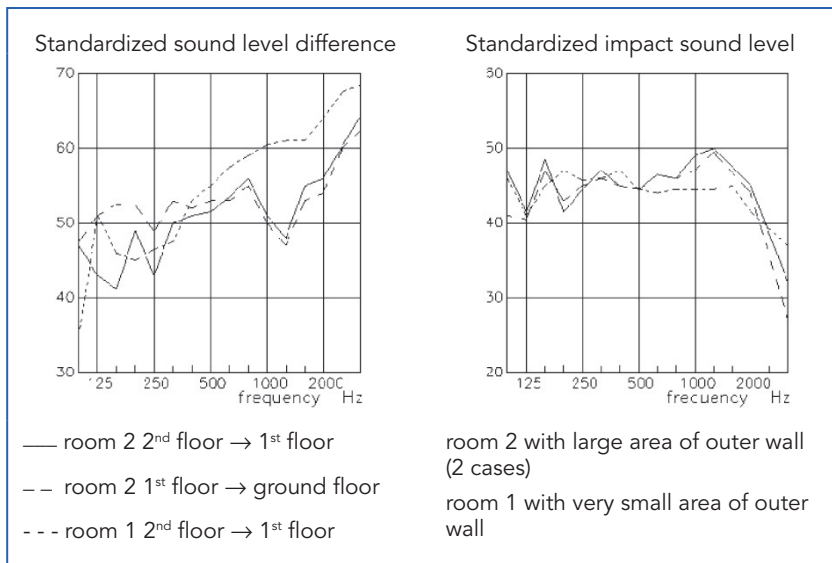
**Figure 1.6.** Flanking wall reduces airborne and impact sound insulation between two rooms one above the other.

A hollow brick wall with a resonance frequency at 1250 Hz flanking a heavy floor with floating screed causes a considerable dip at this resonance frequency in airborne and impact sound insulation between the two rooms separated by the flanked floor.

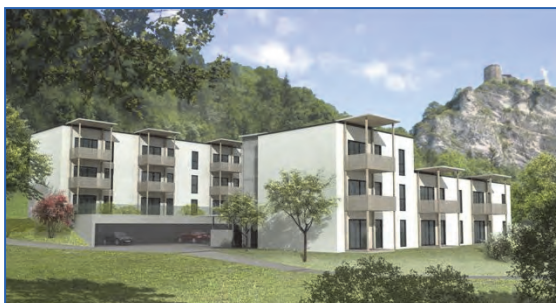
**Figure 1.7a.** Example of a new residential building in timber construction (2010).

In the last few decades, a growing number of multi-storey apartment houses have been built in Austria using timber constructions. When measuring the sound insulation of these buildings, it was found that with proper workmanship (particularly for the wall and floor connections) a high level of sound insulation can be achieved. For instance, when measuring the sound insulation in a multi-family house where the walls and floors had been constructed according to the shown figures the following weighted standardized sound level differences were found:  $D_{nT,w} = 64$  dB (c.f. Figure 1.12) between adjacent rooms and  $D_{nT,w} = 56$  dB between rooms located on top of each other.

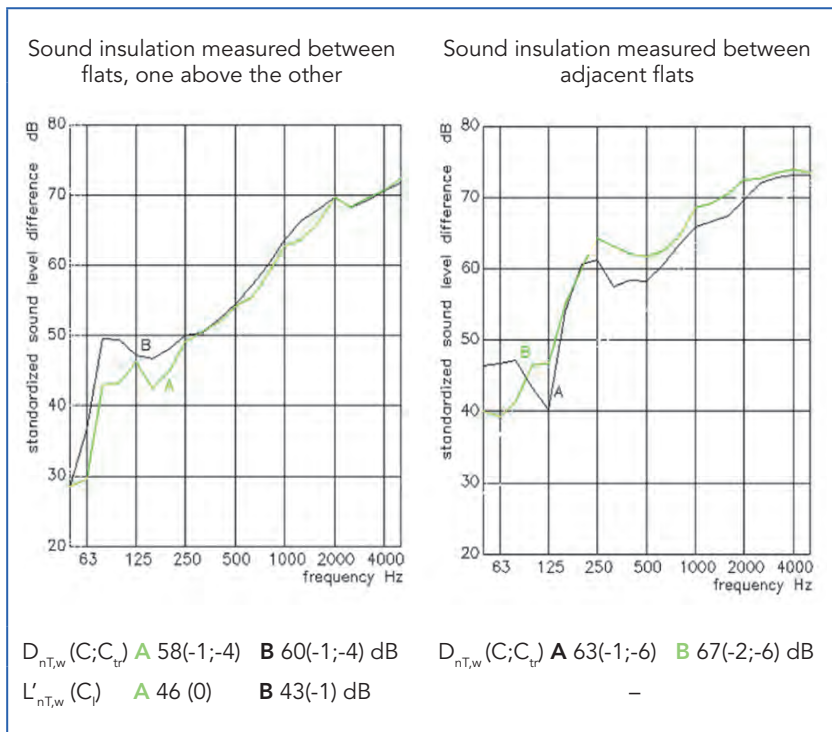
Figure 1.8. Results of sound insulation measurements in the houses A and B.

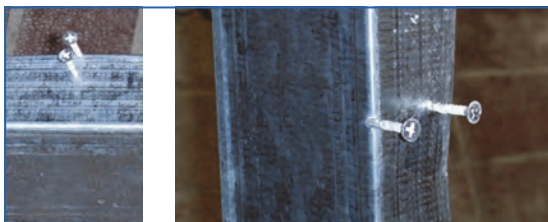
**Figure 1.15.** Position of the screws: left optimal, right suboptimal.

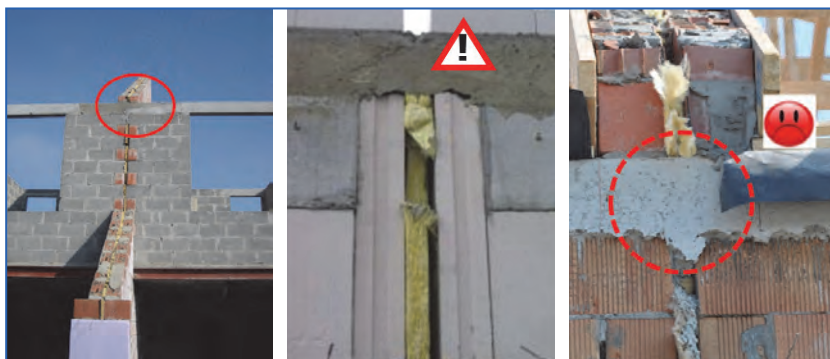
*Figure 2.7. Hard connections (continuous floors, concrete beams but even small metal ties can largely reduce the sound insulation; the party wall loses its acoustic double wall behaviour and extra flanking transmission will occur.*

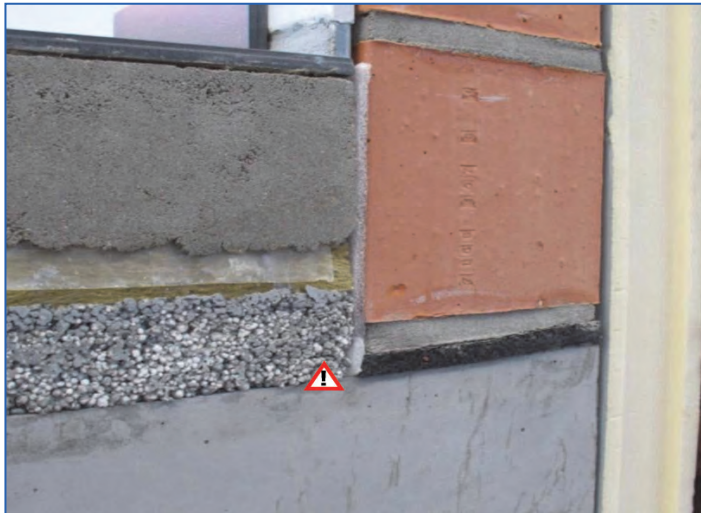
**Figure 2.12.** Detail of concrete slab with floating floor and acoustic strip (Sonic strip, Wienerberger – CDM). It is important to put a border resilient strip before executing the levelling screed to avoid a hard contact between the concrete slab and the brick wall!

- A great quantity of mortar bridges connecting the brick wall and the floor slab can deteriorate the sound insulation;
- When no elastic border strip is placed against the brick wall before pouring the levelling screed, then this latter can form a “vibration bridge” between the brick wall and the concrete slab, deteriorating seriously the sound insulation (see Figure 2.12);

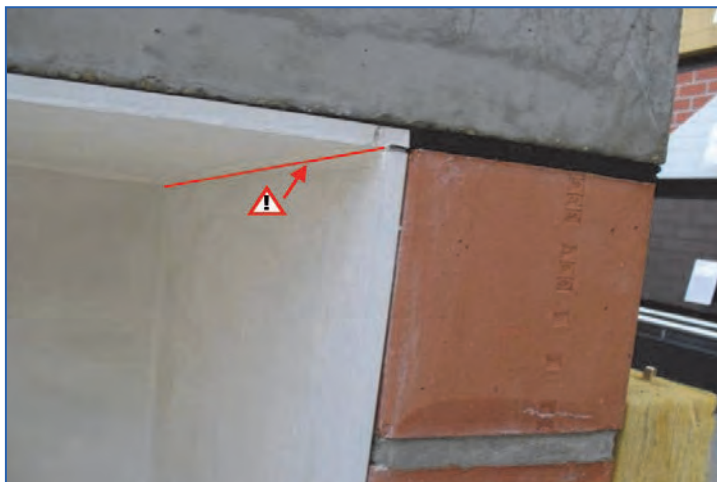
**Figure 2.13.** Detail of the acoustic strip below the concrete slab and on top of the wall. It is always important to cut the plaster at the junction between the brick wall and the concrete slab to avoid cracks (different thermal dilatation), but when using acoustic strips, it should be cut completely down to the acoustic strip and filled up with silicones to avoid a “vibration bridge”.

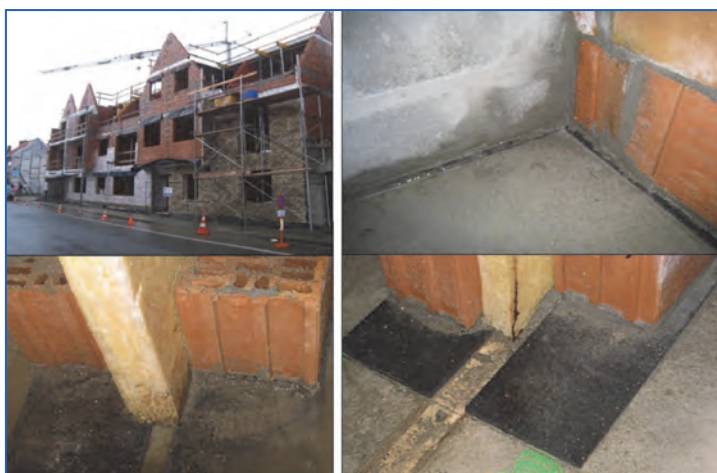
**Figure 2.14.** Application of acoustic strips below brick walls (party wall below) and concrete blocks (the elevator shaft). The acoustic strips (CDM, Sonic strips) have only a limited deformation (2 mm under the weight of the building, almost no creep in time).

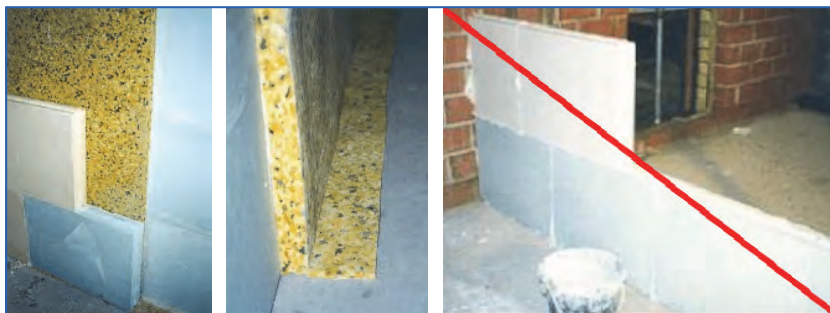
**Figure 2.21.** Gypsum block walls need to well disconnected from the surrounding structure.

The party wall between two apartments or row houses consists of a double gypsum block party wall. The composing walls must have different thicknesses (to create compensating coincidence dips due to shifted critical frequencies). Cavity distance and surface mass of the blocks should be chosen in such a way that the mass-spring mass resonance shifts below 50 Hz. The load bearing brick wall (or other) should be interrupted at the cavity of the party wall to avoid horizontal flanking transmission. The (ceiling) concrete slab should have a surface mass of more than 650 kg/m<sup>2</sup> to limit the vertical and horizontal flanking transmission. This building concept is mainly used for the construction of apartments with a concrete frame structure. Absolute attention should be paid to the decoupling of the gypsum blocks of the surrounding structure so as to maintain the acoustic double wall behaviour of the party wall. Moreover, if not well disconnected from the floors or walls, then the badly situated critical frequency can cause most annoying noise radiation at the lower mid frequencies (equipment noise, impact noise, flanking transmission, etc.).

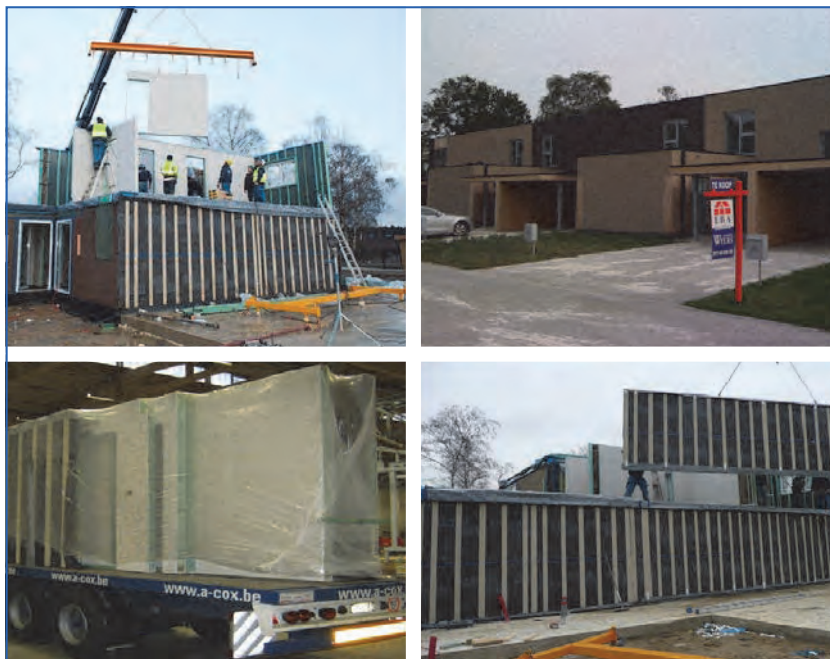
**Figure 2.24.** The newly developed party wall with improved fire and acoustic performances, are now regularly being built (prefabrication).

Light weight timber frame constructions in Belgium are popular for detached houses. In the last couple for years we see an expansion towards row houses and even small apartment constructions. Recent research in the BBRI allowed greatly improving these constructions, especially in their low frequency performance. First new party walls were developed ( $R'_{\text{living},50} > 64$  dB), in a second phase, new floors were developed ( $R_{\text{living}} > 65$  dB and  $L_{n,T,w} + C_{1,50-2500} < 48$  dB). After optimisation for non-acoustic aspects such as fire protection, building cost, airtightness, structural behaviour,... we came to the concept as shown in the figures here below. The first apartment constructions applying these designs are now being built. The new party wall is already popular for the construction of row houses (see figure just below).

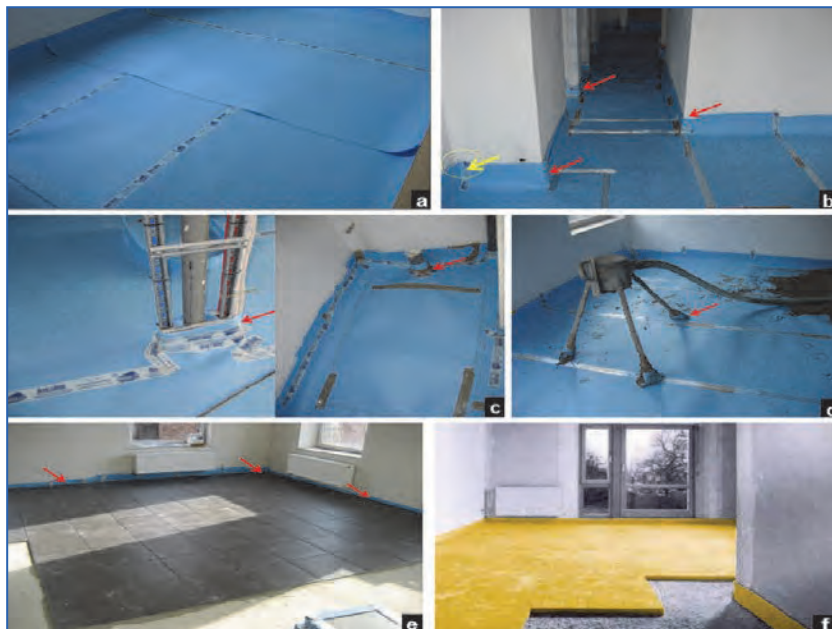
**Figure 2.35.** Correct mounting of a floating floor.

pipes and electric wiring in a levelling layer. After cleaning the level layer of all screws, stones or anything that can puncture the elastic foil, an elastic interlayer (see pictures of the correct execution below) is placed on top of the levelling screed, with a correct overlap and taping between the different foils. A correct placement at the borders is imperative (e.g. by upwards bending the foil against the walls). When the screed is put in place, the border foil should still be visible and not to be cut off before all the tiles are placed. Plinths are finally mounted to the walls, so that an elastic joint (silicones) remains the only connection with the floor tiles. Semi-heavy load bearing floor systems as shown in the Figure 2.34 can create serious acoustic problems when used for the construction of apartments. A sufficient thick layer of concrete ("the compression layer") should be poured on top of the above system in order to create sufficient surface mass. If lacking, then as shown in the formula for the mass-spring-mass resonance frequency, this  $f_r$  will increase! This could theoretically be compensated by a less rigid elastic interlayer, but most elastic interlayers are produced (and tested) to function with heavy load bearing floors. Conclusion: too light load bearing floors will have bad impact sound insulation and offer a bad vertical direct sound insulation. Because of its light weight, it will also allow for some important flanking transmissions!

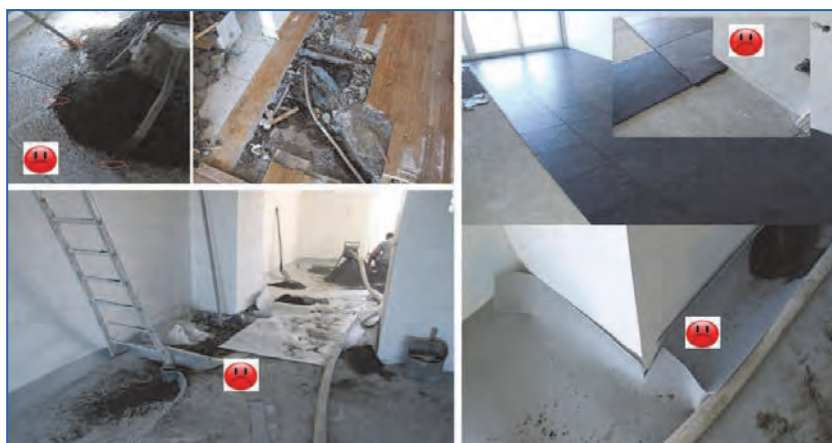
**Figure 2.36.** Bad execution of a mounting floor; sharp objects can puncture the elastic interlayer. Foils should have sufficient overlap and should be taped together. The against the wall upwards turned elastic interlayer should only be cut off after the tiling (if before, the tiles or the glue can make a hard connection with the wall, seriously diminishing the impact and airborne sound insulation of the floating floor).

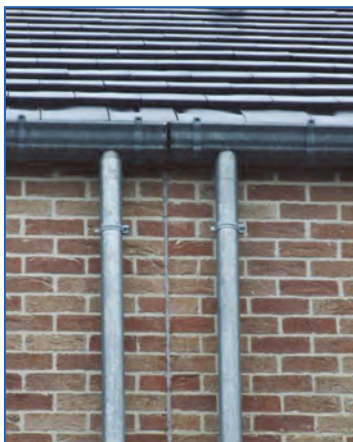
**Figure 2.37.** The interruption of the outer façade wall will allow gaining 1 or 2 dB extra in sound insulation.

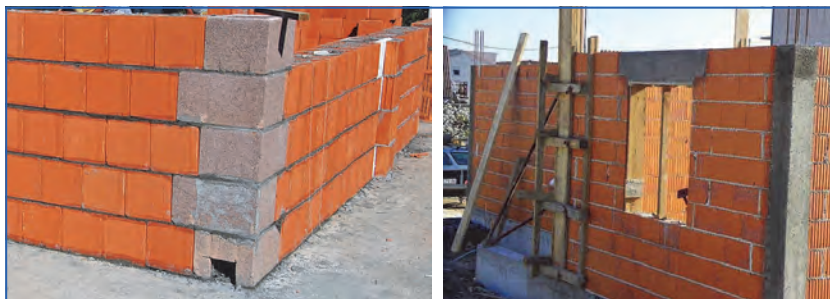
**Figure 3.6.** Anti-earthquake reinforcements done properly (left) and improperly (right).

- a) solid reinforced concrete walls (thickness  $d = 20$  cm)
- b) block-brick walls ( $d = 25$  or  $30$  cm); as an anti-earthquake measure, horizontal and vertical reinforcements are made of reinforced concrete or dedicated building blocks, in the corners of the structure and at the junctions of load-bearing walls and slabs (Figure 3.6)
- c) reinforced concrete skeleton filled with block bricks ( $d = 25$  cm)

The use of anti-earthquake reinforcements is common, although in many older (and, sadly, new ones as well) buildings they are improperly implemented because all the bricks at the edges of a brick section (where they meet with concrete reinforcement) are aligned vertically, and they must not be. In this

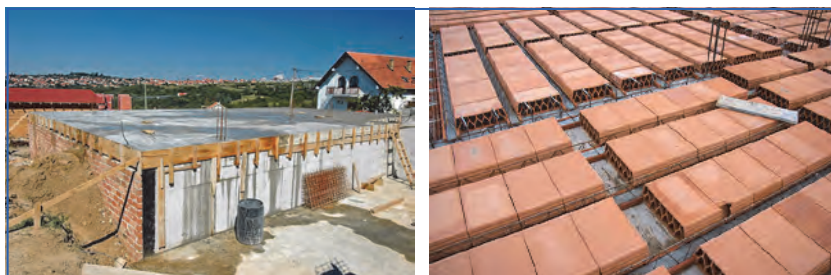
**Figure 3.8.** *The most common floor slab designs: reinforced concrete (left) and brick system (right).*

Heavyweight floors are generally used. In most cases, floors are constructed as solid reinforced concrete slabs, as shown in Figure 3.8. In smaller buildings, mostly single-family houses, brick-based floors are used

as well, as shown in Figure 3.8 as well. Prefabricated concrete slabs are also used, manufactured as thin concrete panels with the necessary reinforcement, which are then finished in-situ to their full thickness.

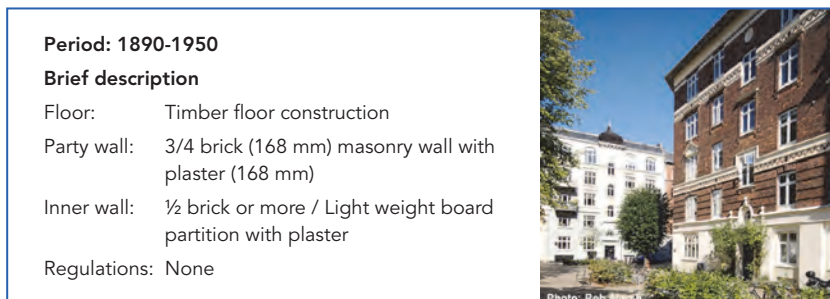
**Figure 5.16.** Brief description of building type commonly used up to 1950. The photo shows a typical type of building from this period.

An example of a typical Danish apartment building built before 1950 is shown in Figure 5.16.

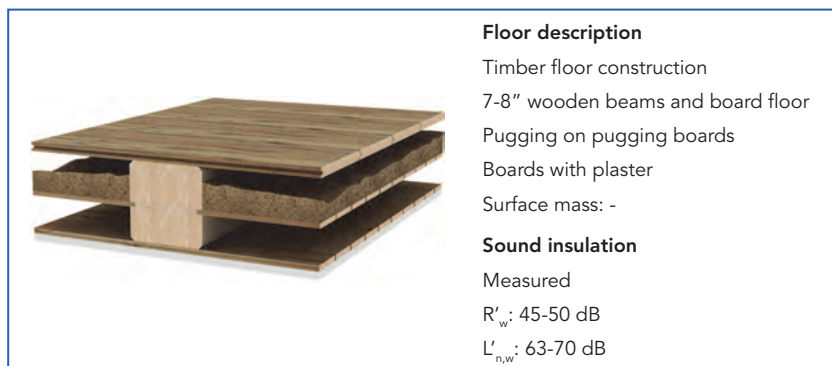
**Figure 5.18.** Floor performance in building type commonly used up to 1950. Drawing from [9], [15].

Figure 5.17 and Figure 5.18 show the typical sound insulation performance between common Danish apartments built before 1950.

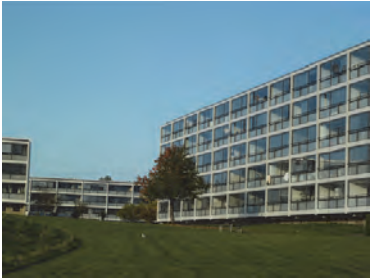
<p><b>Period: 1970-2008</b>                  Brief description:                  Floor: 180-220 mm hollow core concrete slabs with wooden floor on joists on PE wedges                  Party wall: 150 mm precast concrete walls                  Inner wall: Aerated concrete / Light weight plasterboard walls                  Regulations: e.g. BR1982 and BR1995</p>

Regulations	Airborne Horizontal	Airborne Vertical	Impact				
Sound insulation	↔	↕	↕				
Descriptor	$R'_w$	$R'_w$	$L'_{n,w}$				
Frequency range	100-3150	100-3150	100-3150				
Value	52 dB	53 dB	58 dB

**Figure 5.20.** Brief description of building type commonly used from about 1960. The photo shows a typical type of building from that period.

An example of a typical Danish apartment building built after 1960 is shown in Figure 5.20.

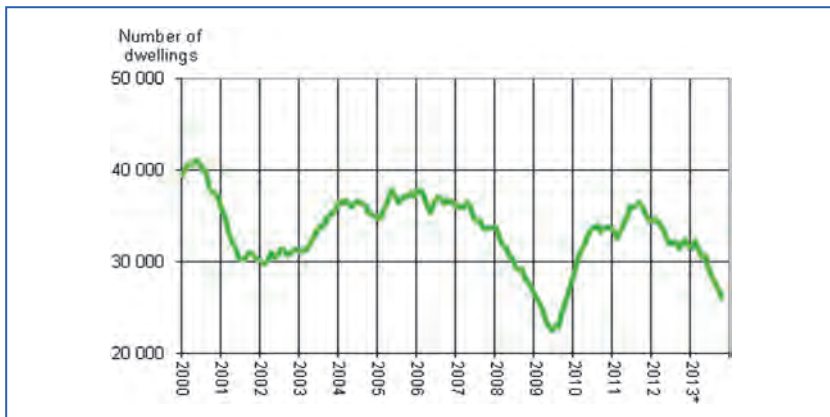
Figure 7.1. Number of building permits granted for dwellings in Finland 2000-2013, variable annual sum [9].

Figure 7.1 presents the number of building permits granted for dwellings [9].

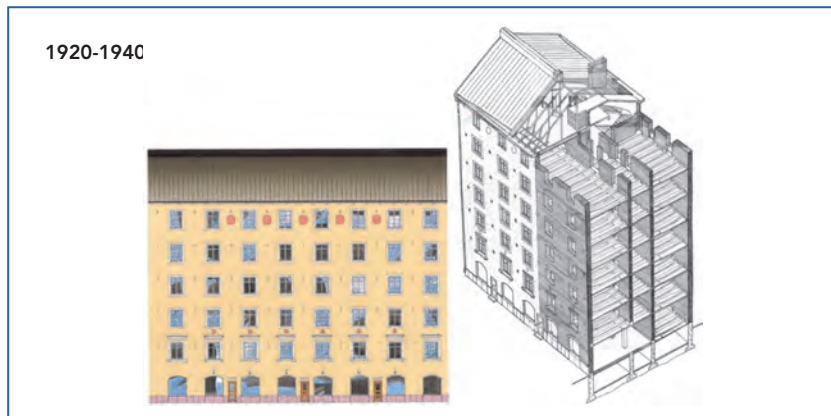
**Figure 7.15.** Example of a dwelling constructed in 1928. Left: façade 1:250, right: cross section. Typical structures: floor: inverted beam, walls between dwellings: double “Lugino mix” wall (an outdated mixture of slag, gypsum, sand and water) [5].

Figures 7.14-7.17 present examples of typical apartment houses and their structures from four time periods [5].

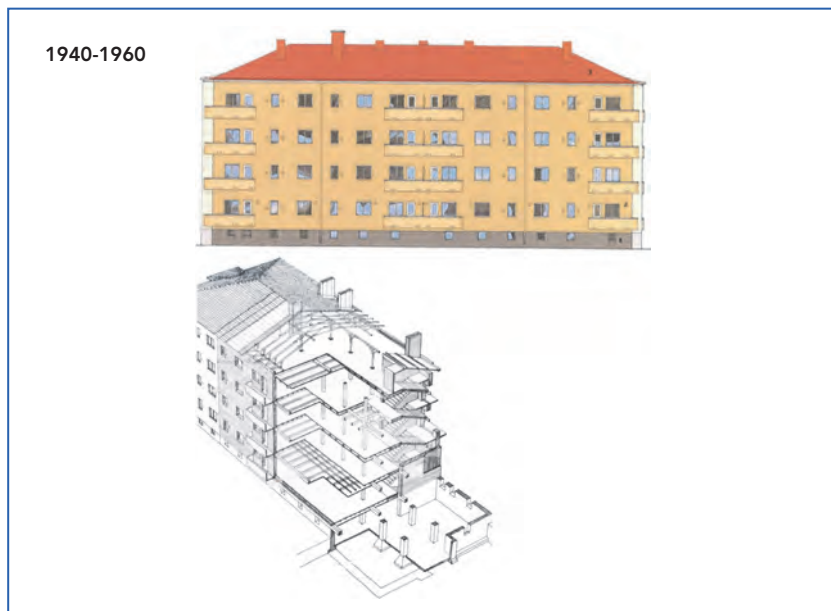
**Figure 7.16.** Example of a dwelling constructed in 1946. Top: façade 1:250, bottom: cross section. Typical structures: floor: inverted beam, walls between dwellings: “Riksi-board” wall (an outdated mixture of woodchips and gypsum) [5].

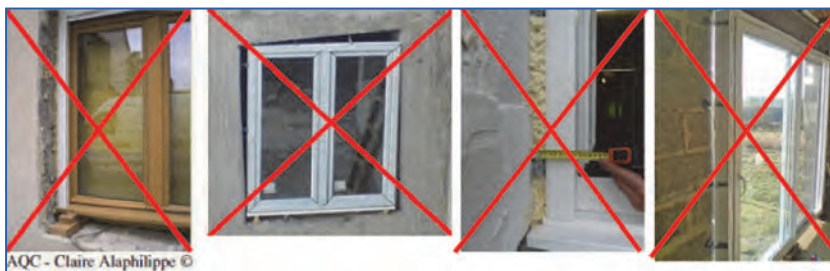
**Figure 8.10.** Example of problems related to windows.

installation of the interior lining around the window frame; some examples of problems encountered with mounting windows are shown in Figure 8.10.

Some of these errors are illustrated in Figures 8.10 to 8.12.

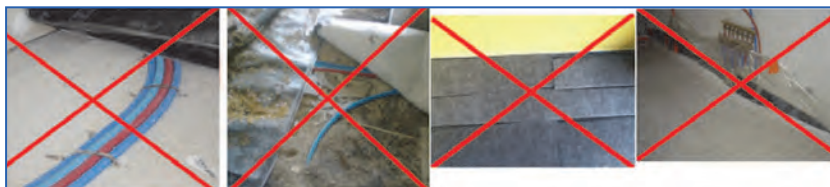
**Figure 8.11.** Example of problems related to floating floors.

- Floating floors: poor preparation of supporting slab (evenness, cleanness), poor installation of resilient layer and/or flanking strips (discontinuity), improper placement of skirting boards connecting the floating floor and walls, improper consideration of specific points such as beams, pipes, bottom part of patio door frame.

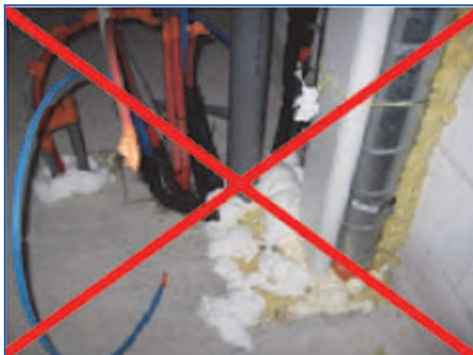
**Figure 8.12.** Example of problems related to piping system going through separating floor slab.

- Landing door opening directly on the living spaces: missing joint or wrongly installed, unevenness and squaring defect of the frame, unevenness of door leaf due to stocking in bad conditions.
- Separating wall between dwellings : electric components (light switch, power socket) positioned back-to-back, interior lining mounted continuously between two dwellings.
- Separating floors between dwellings: holes around piping systems (water waste etc...) going through floor slab (see Figure 8.12 for example).

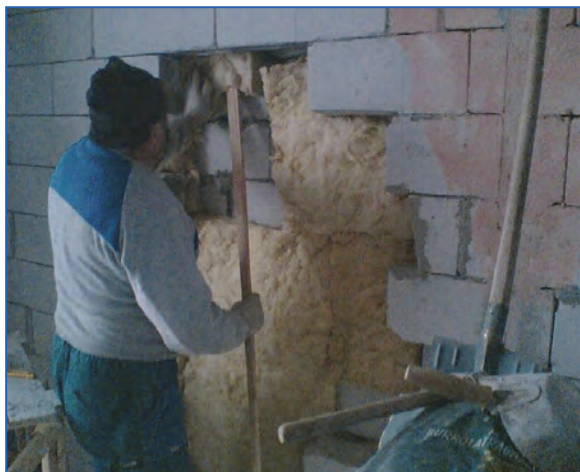
**Figure 11.7.** Stuffing the cavity with glass wool – a typical workmanship error of constructing double walls and furrings.

The bottleneck of constructing double walls (and furrings) is the cavity filling. A typical workmanship error is to completely stuff the cavity with glass or mineral wool (put as much as possible), instead of simply placing the sheets in there. Sometimes the construction manager even takes photographs to prove how properly the cavity was filled (stuffed), see the picture below. Of course such a document is a great help when investigating the reason for poor sound insulation performance.

In the case shown above, the separating wall was made of the same aerated concrete blocks as in the previous example. The error in the design is obvious from the technical document that says '*separating walls are made of one layer of 100 mm thick YTONG (aerated concrete) blocks*' – the same construction as used within the dwelling for the inner separator walls (that have much lower acoustical requirement). Despite the technical document, the realised wall was a double leaf construction of these aerated concrete blocks, with cavity between – reason for this change is unknown. The picture shows an attempt to increase the sound insulation with opening up the wall and placing glass wool in the cavity.

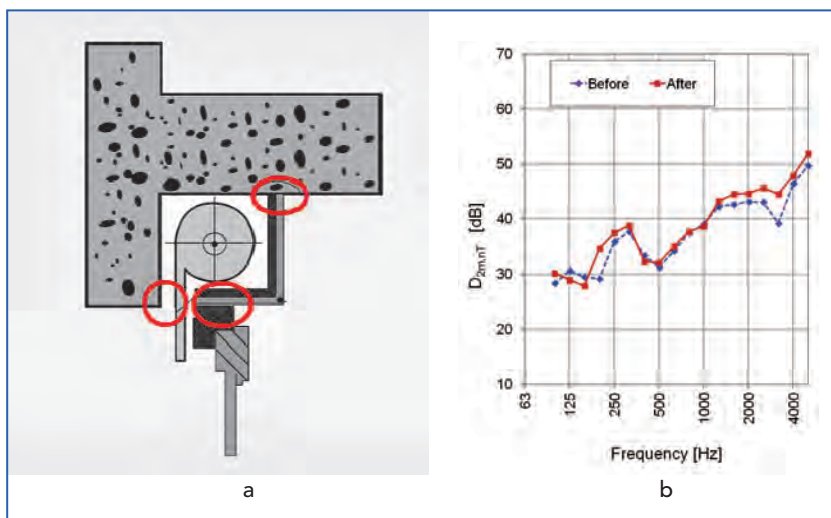
**Figure 13.11.** a) Leakages between shutter box, wall and window frame, b) Case study: façade insulation before and after sealing between shutter box and wall.

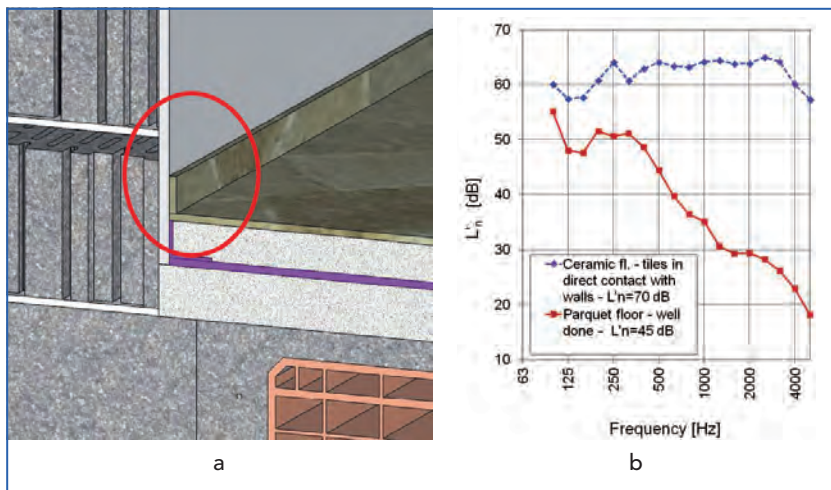
**Figure 13.13.** a) Example of tiles in direct contact with the walls and skirting board in direct contact with the floor, b) Impact sound with different paving: ceramic tiles with workmanship errors as in the picture, parquet floor well done.

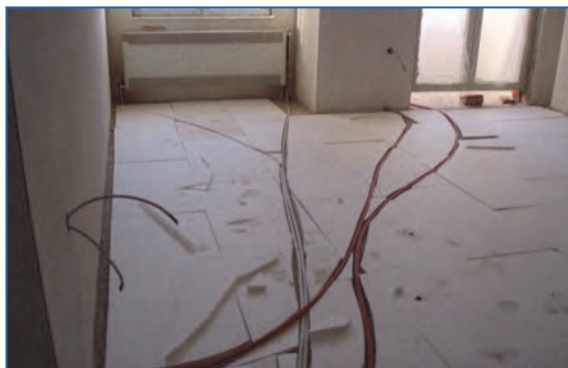
**Figure 15.7.** Typical error in workmanship – broken insulation.

The following figures illustrate the typical errors in design, as the example with broken insulation in the Figure 15.7, when too many cables and pipes have to cross the floor.

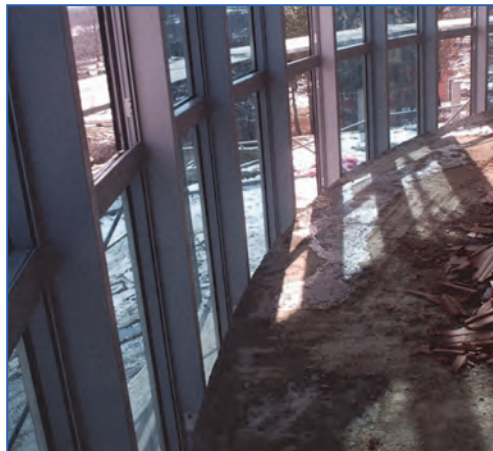
**Figure 15.9.** Typical error in design – building envelope of steel and glass.

New contemporary architecture, for example the buildings made of glass and steel, are not usually friendly oriented towards the good acoustic performance of the buildings, Figure 15.9.

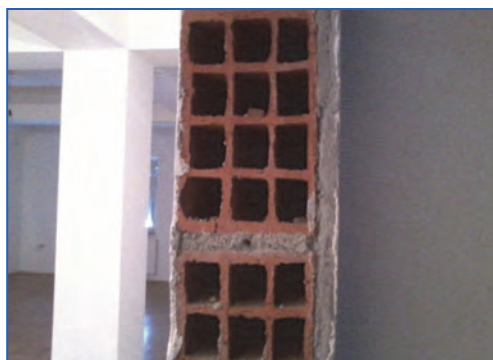
**Figure 15.11.** Typical errors in workmanship – irregular mortar layers.

Some of the most common typical errors in workmanship which diminish the airborne sound insulation are presented in the following figures: holes for installation services on the walls (Figure 15.10), lack of mortar in vertical joints between the bricks (Figure 15.11), or irregular thickness or lack of mortar on the surface layers (Figure 15.12).

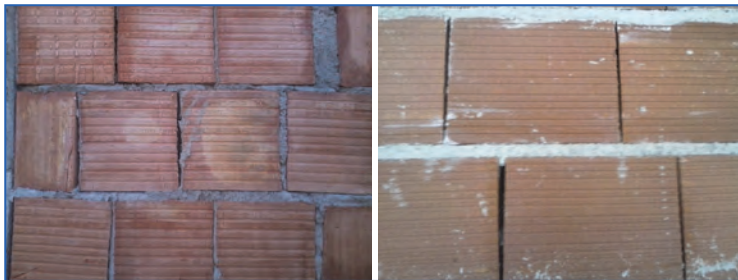
**Figure 15.12.** Typical errors in workmanship – vertical joints not filled with mortar.

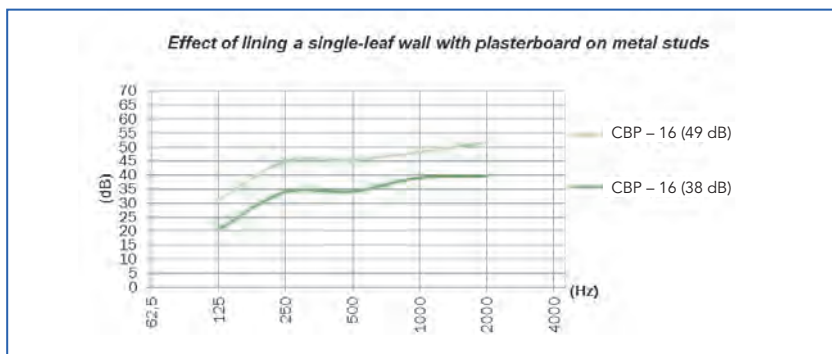
**Figure 15.20.** Improving sound insulation – Effect of lining a single-leaf ceramic block wall 16 cm thick with plasterboard on metal studs.

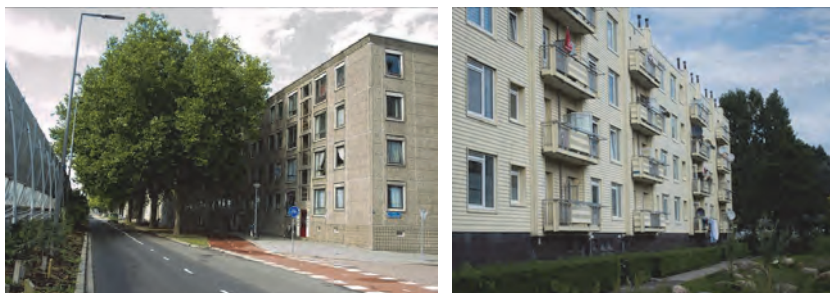
(Left) Porch houses built in the 50's and renovated in the 80's because of sound insulation of the façade and (Right) Porch houses also built in the 60's, renovated in 2010, with as main topic thermal insulation.

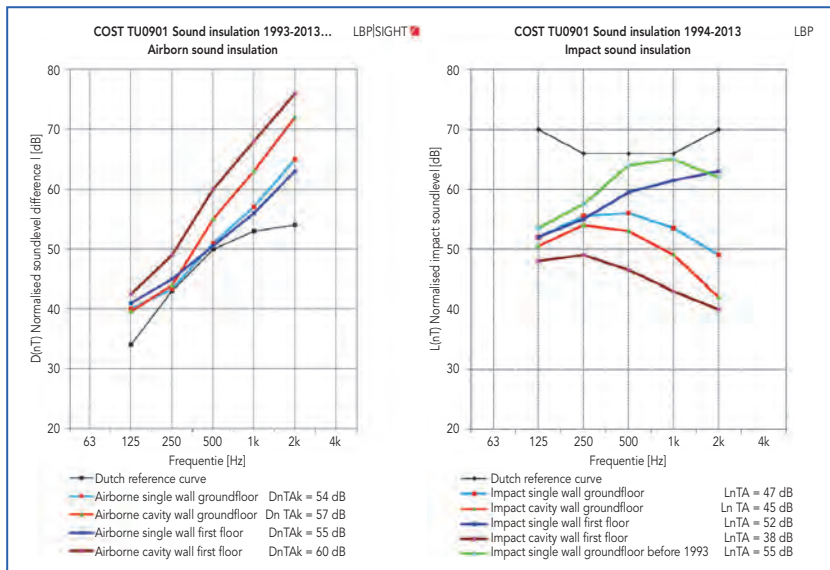
**Figure 17.5.** Average sound insulation in horizontal direction of newly built terraced houses with solid and cavity walls: airborne (left) and impact (right) for the ground floor and the first floor. (Green line: ground floor with old detail (<1994).

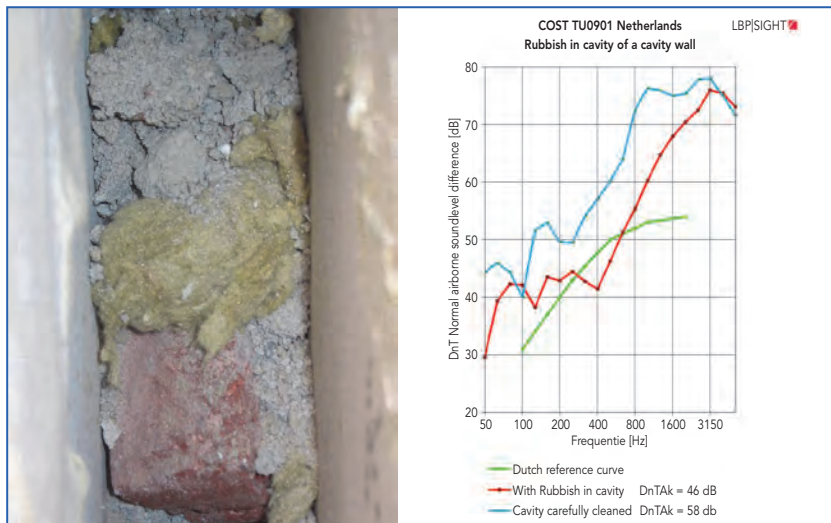
**Figure 17.6.** Rubbish such as screed and pieces of brick in the cavity. The airborne sound insulation before (red) and after careful cleaning of the cavity (blue).

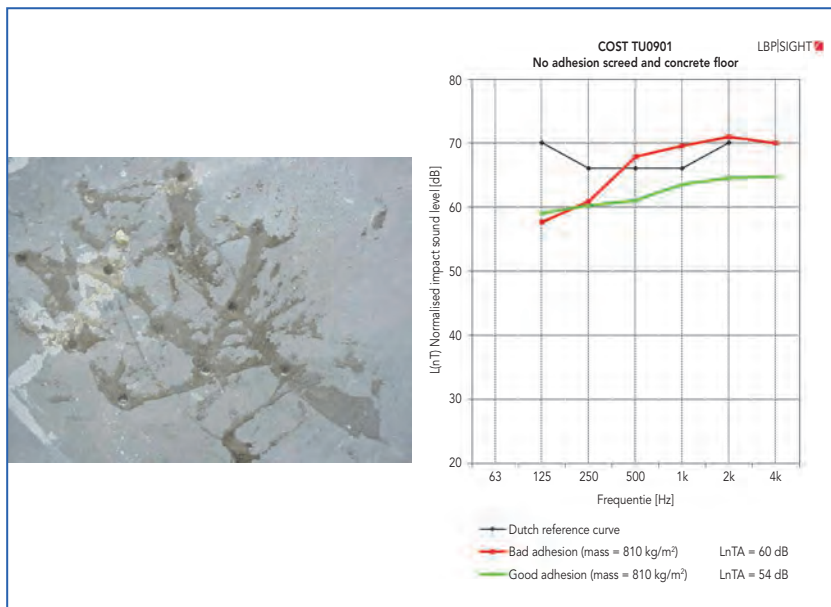
**Figure 17.11.** No good adhesion of the screed or anhydrite (red) with the concrete base floor leads to 5 till 7 dB lower  $L_{nT,A}$  values than good adhesion(green). (right) The picture (left) shows the result of the remedy: Injection in holes ( $\varnothing$  5 mm)with two component resin under low pressure.

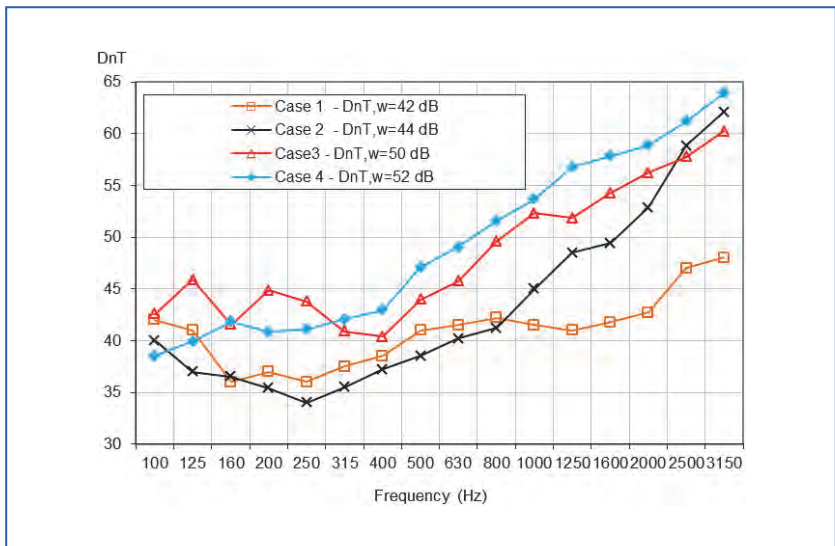
**Figure 20.10.** Case study: airborne sound insulation of partition walls. Case 1- sprayed plaster, empty cavity; Case 2 – sprayed plaster, insulated cavity; Case 3 – traditional plaster, insulated cavity; Case 4- traditional plaster on both sides and on one cavity face, plus insulated cavity.

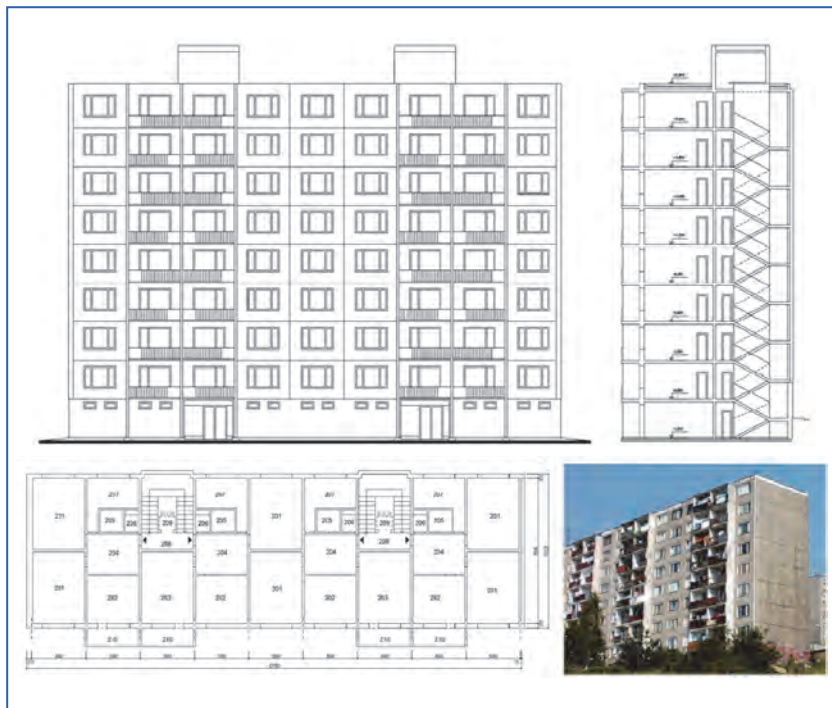
**Figure 23.10.** Multi-family house, row type T06B-KE (slag pumiceous ceramsite concrete panel), [4].

Figure 23.10 shows type T06B row house for region Kosice (KE). This type was built as tower house as well. The front and rear face curtain walls were made by slag pumiceous ceramsite concrete panel, 320 mm thick with density 1450 kg/m<sup>2</sup>. Gable walls were made by 140 mm thick reinforced concrete panel with 240 mm thick facing panel and 5 mm gap between them. The internal walls were made as reinforced concrete panels 140 mm thick and the ceiling slab was made as a reinforced concrete hollow panel 120 mm thick with compact concrete junction.

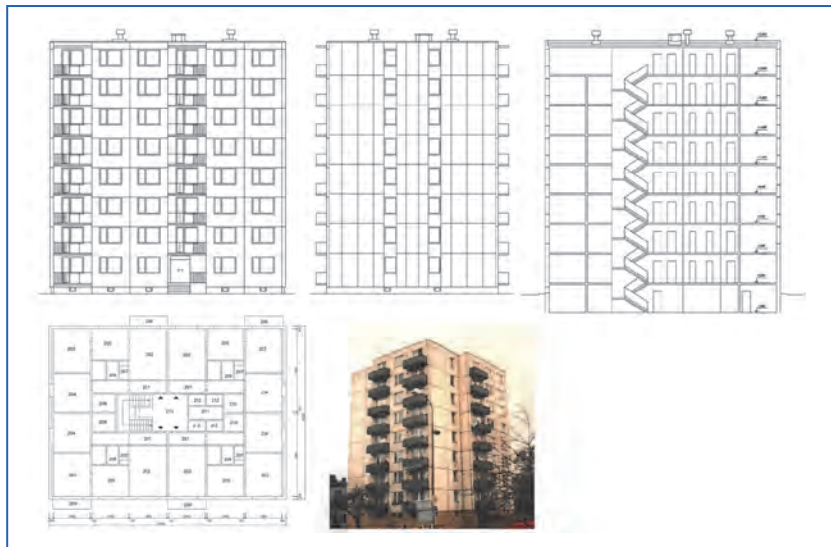
**Figure 23.11.** Multi-family house, tower type T06B-NR (porous concrete panel), [4].

Another type of T06B system for region Nita (NR) shows Figure 23.11. It is a tower multi-family house. The front and rear face curtain walls were made by protruding, self-supporting aerated concrete panel, 240 mm thick. Gable walls were made by 140 mm thick reinforced concrete panel with 240 mm thick aerated concrete panel and 15 mm gap between them. The internal walls between rooms and dwellings were made by

140 mm thick aerated concrete panel and the ceiling slab was made as a reinforced concrete hollow panel 120 mm thick with compact concrete junction.

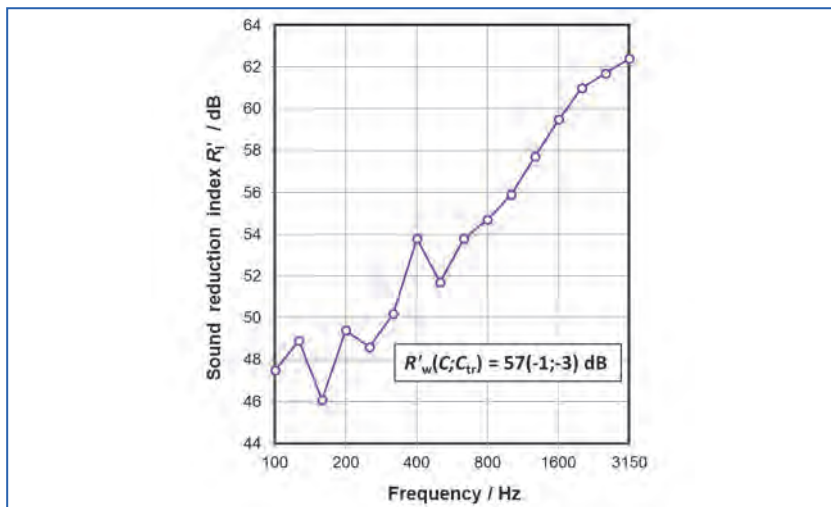
**Figure 24.4.** Case study: an example of sound insulation performance of typical massive wall between adjoining dwellings in the new build apartment block.

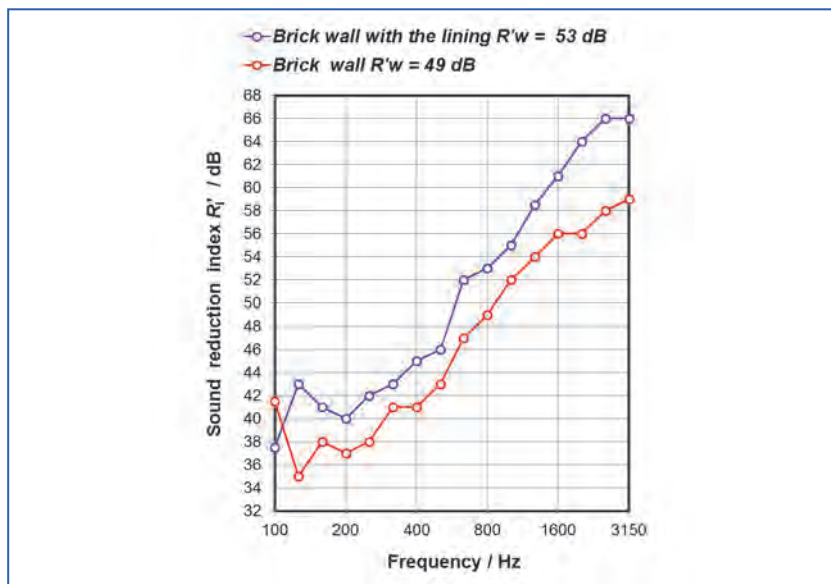
**Figure 24.6.** Case study: an example of sound insulation performance of the brick wall before and after the sound insulation improvement.

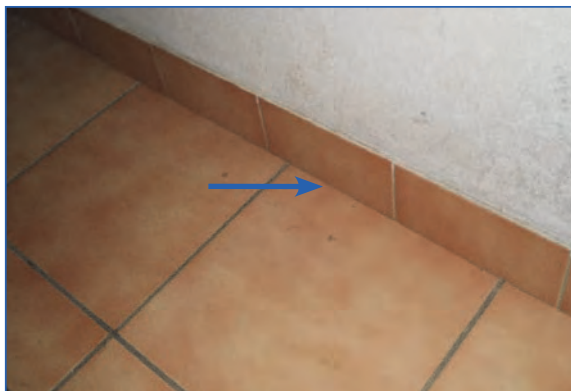
**Figure 24.10.** An example of a rigid contact of wall and screed via floor ceramics.

In many cases there are no rigid contacts between concrete screed and wall, but rigid contact exist via floor ceramics (Figure 24.10).

A typical error in workmanship of the floor construction relates to rigid junction of concrete screed and wall and leads to reduction in impact and airborne sound insulation performance (Figure 24.9).

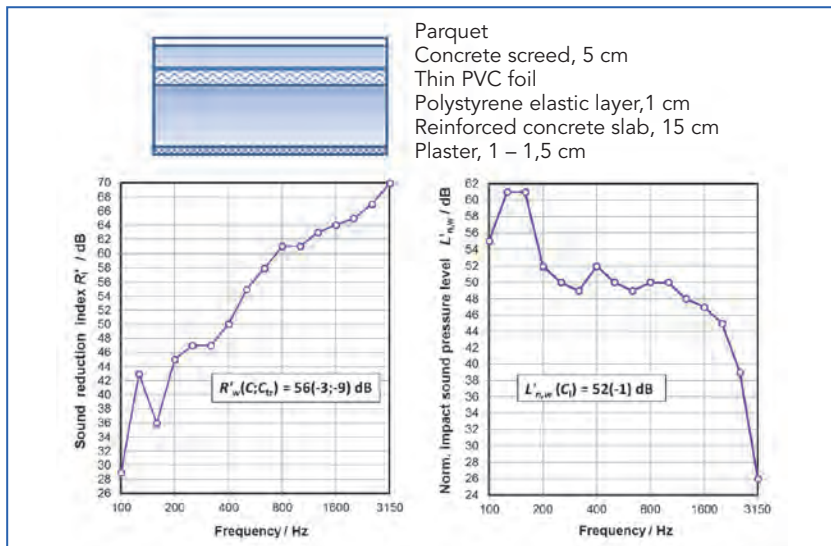
Figure 24.11. Case study: sound insulation performance of typical floor construction with reinforced concrete slab.

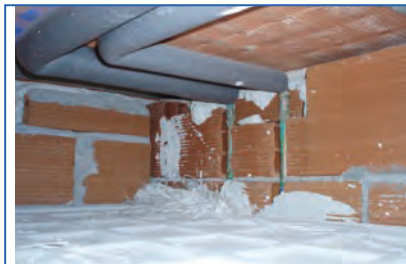
**Bad practice**

Chases performed in the wall are not filled with mortar. Foam lagging is missing in the water pipes that run above the ceiling. Water pipes in contact with the brick wall, transferring structure-borne noise to the wall.

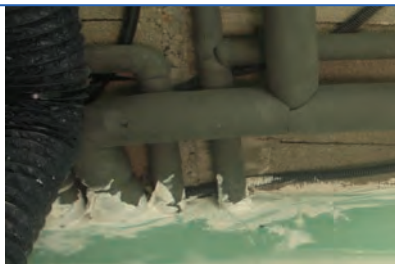
**Good practice**

Water pipes have a foam lagging. When they penetrate the wall, caulking is used to seal their perimeter.

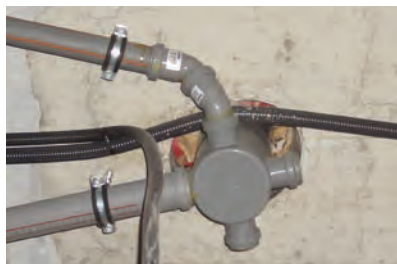
**Bad practice**

Typical bottle trap used in for the appliance drainage. It hangs from the bottom of the slab. Noise due to water flow can be heard in the underlying premises. The gap between the trap and the slab has not been properly sealed.

$L_{A,eq100-10000} = 37,4$  dBA measured in the underlying premises when a suspended ceiling was installed. [10]

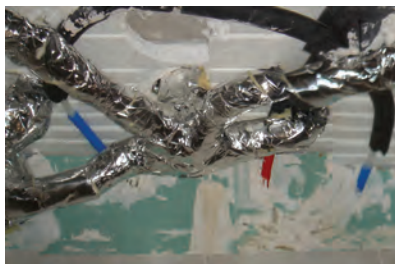
**Good practice**

Glass fibre insulation is used for lagging pipes. After installing a suspended ceiling, the noise emitted due to water flow from the shower decreased in 5 dBA.

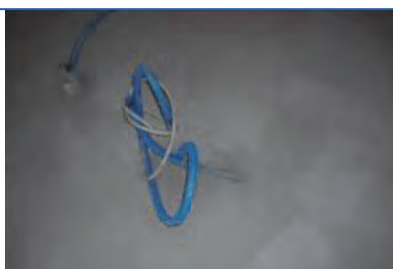
Bad workmanship  
Electric tubes in floating floor  
without insulating sleeve

**Figure 27.22.** Good practice and bad workmanship for pipes through floating screed.

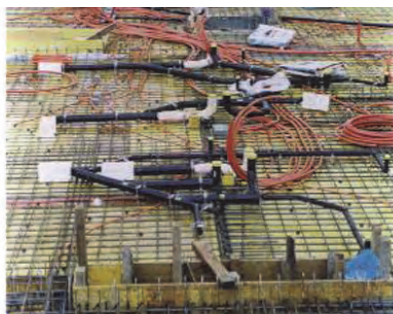
Bad workmanship  
Water pipes in concrete floor  
without insulating sleeve

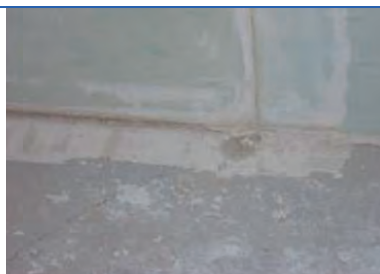
Bad workmanship  
Resilient layer on floor covered  
by plaster

**Figure 27.23.** Good practice and bad workmanship for wall/floor and wall junctions.

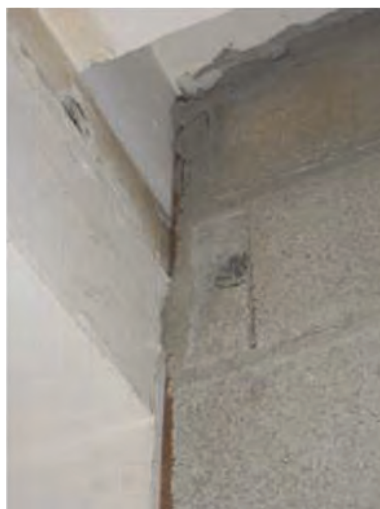
Bad workmanship  
Resilient layer on wall  
covered by mortar

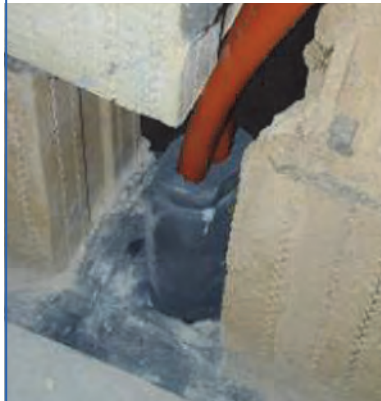
Good workmanship

**Figure 27.24.** Good practice and bad workmanship for pipes through walls.

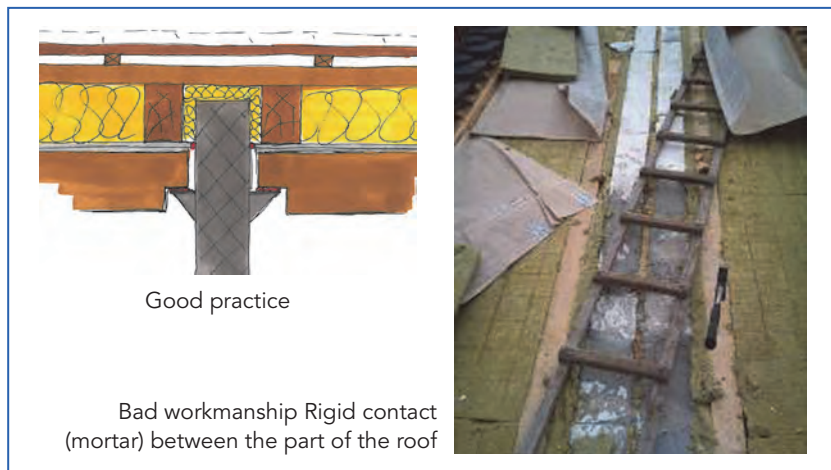
**Figure 27.25.** Good practice and bad workmanship for wall/roof junctions.

The junction between separating wall and roof should be designed to avoid flanking transmissions through the roof (no rigid connection and a good airtightness).

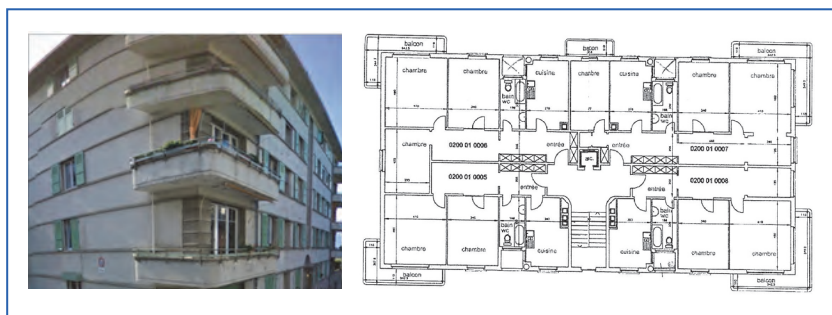
Figure 27.31. Typical construction in 1920-1950 period.

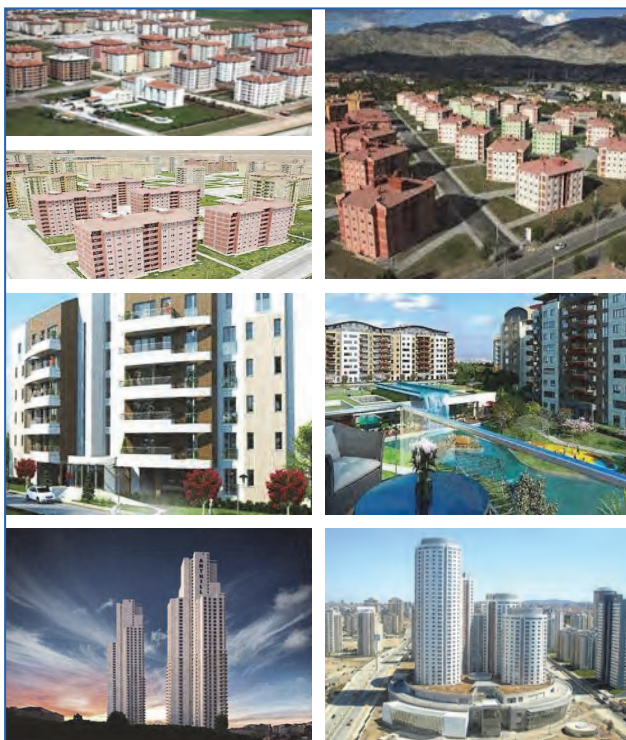
**Figure 28.6.** Samples of the building sites. First row (1,2): Mass houses built by Government (TOKI) especially in earthquake regions and urban transformation areas (concrete frame and all walls of gas concrete). Second row (3,4): New suburban neighbourhoods (buildings with concrete frame and gas concrete walls, some gypsum board interior walls). Third row (5,6): High-rise residential blocks in Istanbul (curtain walls, some steel framed, interior walls of gypsum board constructions). Ref. [4].
