**COST Action TU0901:  
Integrating and Harmonizing Sound Insulation Aspects  
in Sustainable Urban Housing Constructions**

# **Building acoustics throughout Europe Volume 2: Housing and construction types country by country**

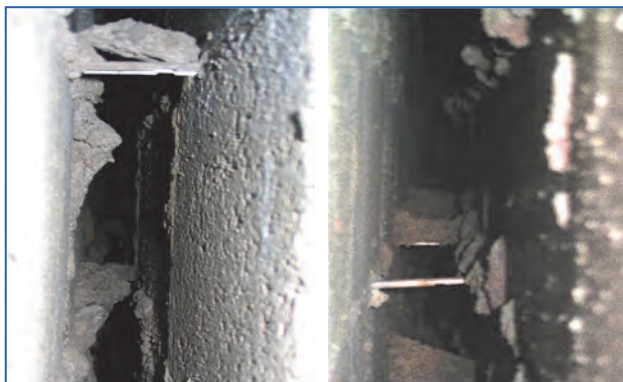
**Figure 29.6.** Example of poor workmanship in cavity separating walls, showing incorrect wall ties and also mortar being allowed to collect on ties (these provide strong acoustic bridges which weaken the sound insulation performance by 6 dB to 10 dB).

- core construction – incorrect blockwork density;
- junction designs – running the inner leaf of the external wall through, dwelling to dwelling, past the separating wall, creating strong flanking path;
- insufficiently filled mortar beds;
- wrong wall ties; and
- mortar collection on wall ties and not being cleaned off (as shown below in Figure 29.6).
